Salt River Pima-Maricopa Indian Community

MONTHLY PROJECT PROGRESS UPDATE

Project: ECEC Classroom and Parking Expansion

Issued Date: August 4, 2023 | **August-2023 UPDATE**

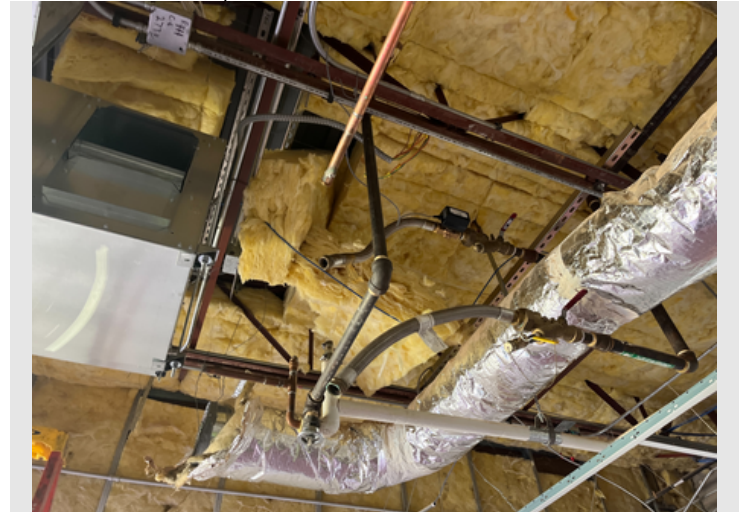
Old hose and valves to be replace with new.

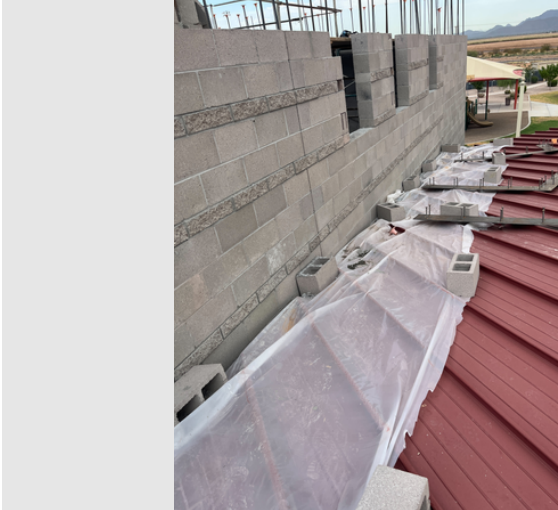
Plastic over exciting roof line that we had to cut for new bldg

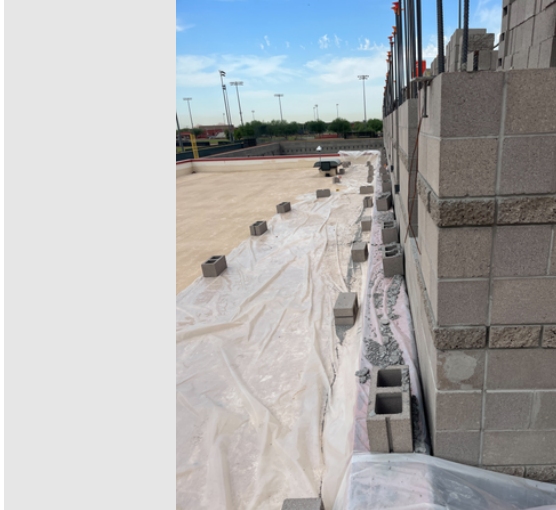
Plastic over exciting roof line that we had to cut for new bldg

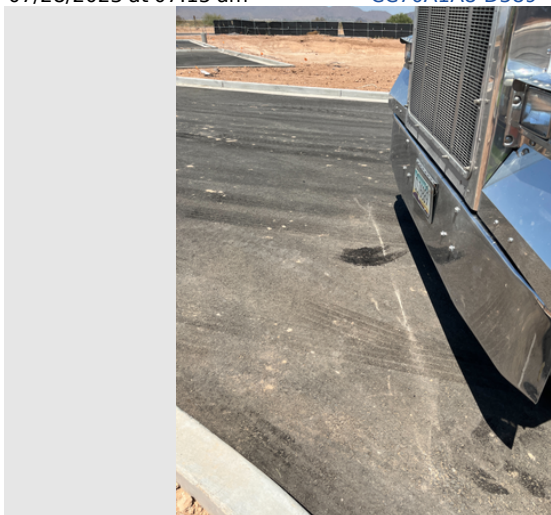
Asphalt damage by steel delivery 7-26-23 2:30 PM

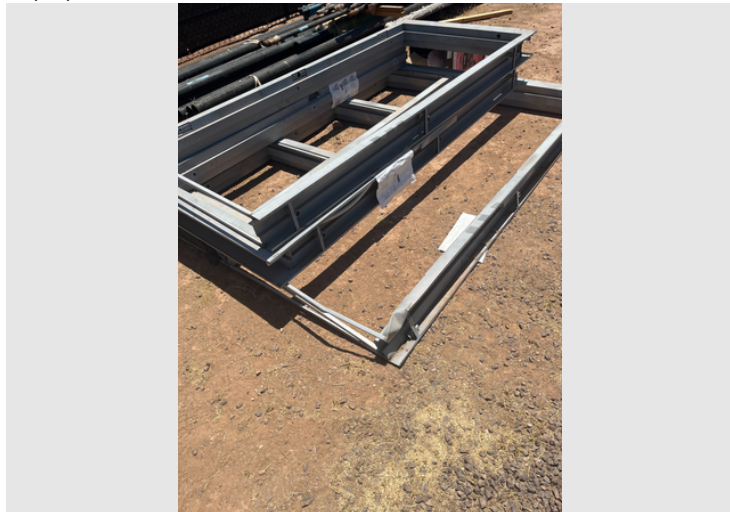
CJS forklifts operator run over door at lay down yard with his rear right tire.

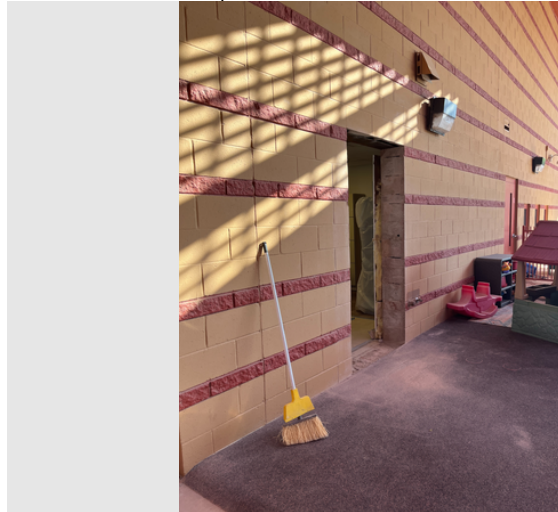
Excysting cells hollow need to work with mason on filling cells for new door install.

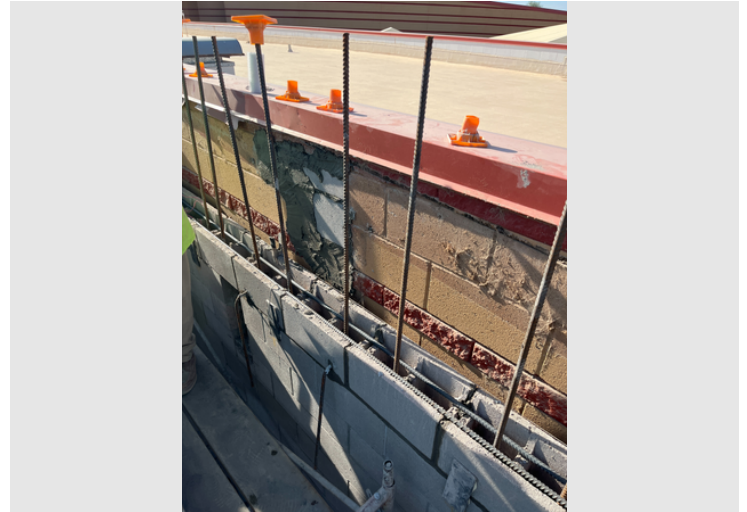
Repairs at excysting bldg.

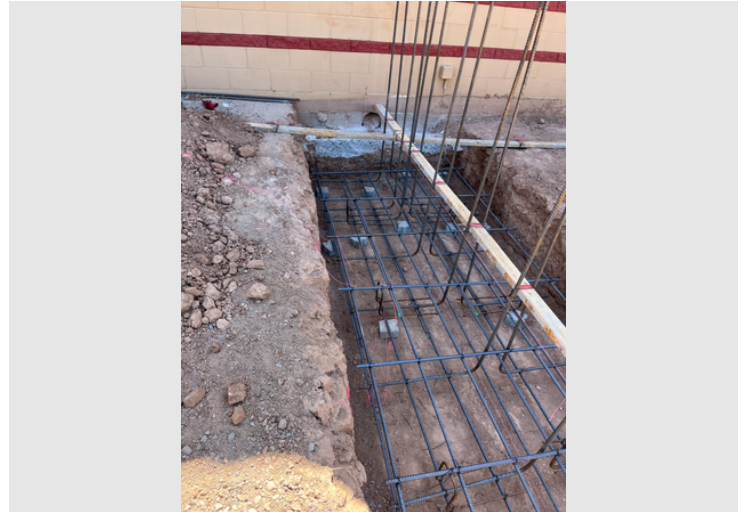
Mechanical yard Rebar inspection today it pass. and electrical sleeve has been removed.

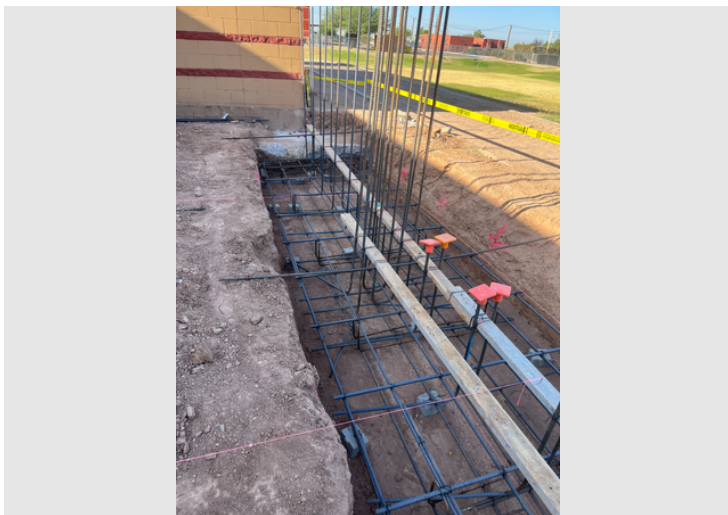
Verticals all good ready for concrete pour.

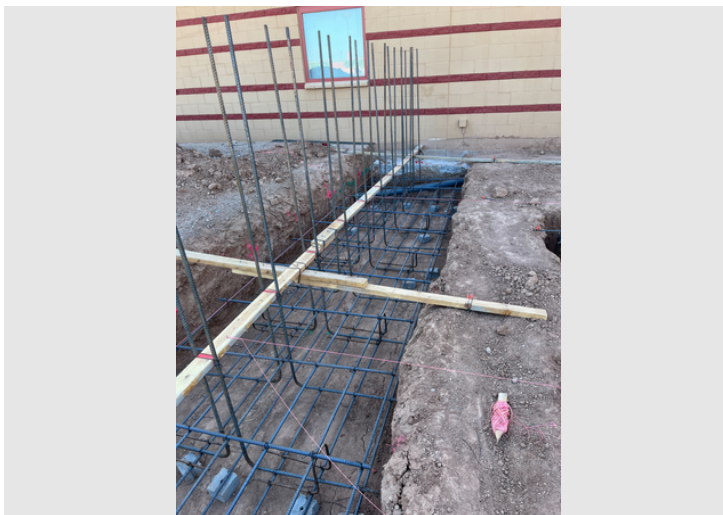
Electrical sleeve needs to be removed per city inspector.

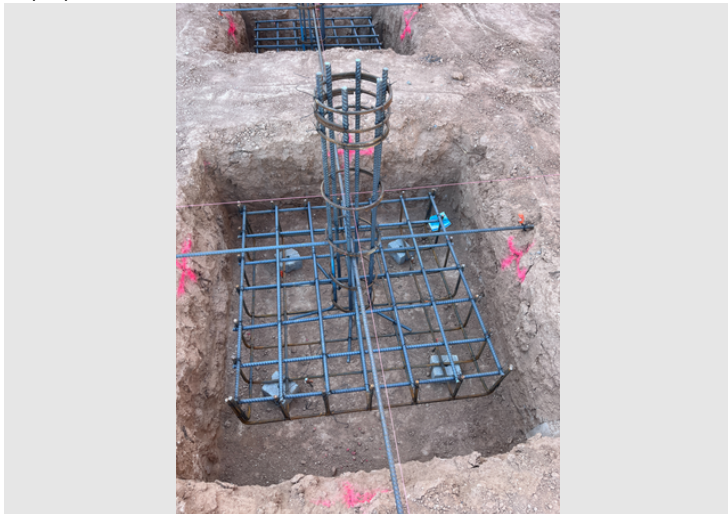
Pedestals all good and pass inspection ready for concrete.
